**Flood Control Project Maintenance
Levee Inspections**
LMA District Cover Sheet
Spring 2018 Levee Inspection Results

Madera County FCWCA

**Flood Control Project Maintenance
Levee Inspections
Unit Cover Sheet
Spring 2018 Levee Inspection Results
Madera County FCWCA**

Waterway			Bank	Unit Miles
Unit No. 01 Ash Slough			Right	2.37
	Spring (March - May)	Summer (June - August)	(September - November) Fall	Winter (December - February)
Unit Maintenance Rating (Fall Only)				
Date of Inspection	4/17/2018 - 4/17/2018			
DWR Inspector	Richard Willoughby			
Accompanied By

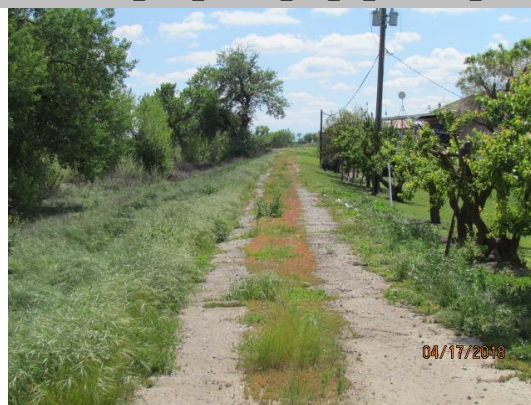
Photo 1 of 1 : SP_2018_NA0011_142_22_20180420_00029.jpg

LM Start	0.39	Rating **	M	Issue No.	22
LM End	0.87	Issue Type +	Ma	Location *	CR
Category	Earthen Levee			GPS Latitude/Longitude	
				Start	End
Item	Vegetation			37.048906 °	37.054495 °
				-120.421793 °	-120.417028 °
DWR ID	DWR_NA0011_01_s _ 2018_22				
Comment Code					
V9 : Keep the crown roadway free of vegetation.					
Inspector Comment					
Control veg on levee crown.

Looking west at veg on levee crown within the section. (Spring 2018)

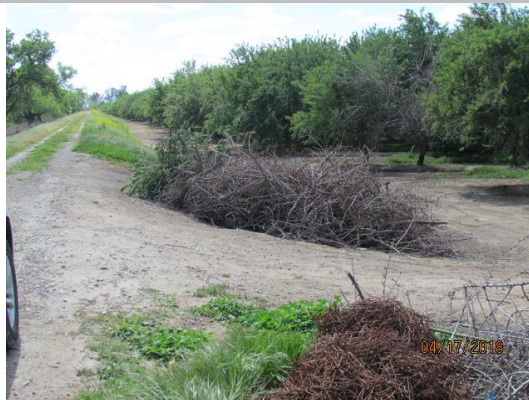
Photo 1 of 2 : SP_2018_NA0011_142_13_20180420_00030.jpg

LM Start	0.59	Rating **	U	Issue No.	13
LM End	0.59	Issue Type +	En	Location *	LS
Category	Earthen Levee			GPS Latitude/Longitude	
				Start	End
Item	Encroachments			37.050920 °	37.050920 °
				-120.419210 °	-120.419210 °
DWR ID	DWR_NA0011_01_f_2017_13				
Comment Code					
PR : Prunings					
Inspector Comment					
Remove the large pruning piles on landside slope.

Looking west at pruning pile on landward slope. (Spring 2018)

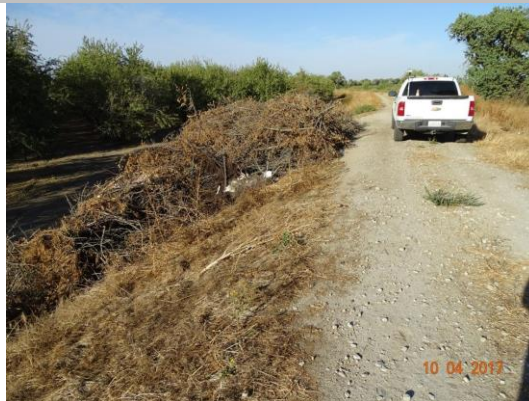
Photo 2 of 2 : SP_2018_NA0011_142_13_20180411_00004.jpg

LM Start	0.59	Rating **	U	Issue No.	13 (cont)
LM End	0.59	Issue Type +	En	Location *	LS

Remove large pruning piles from landside slope.

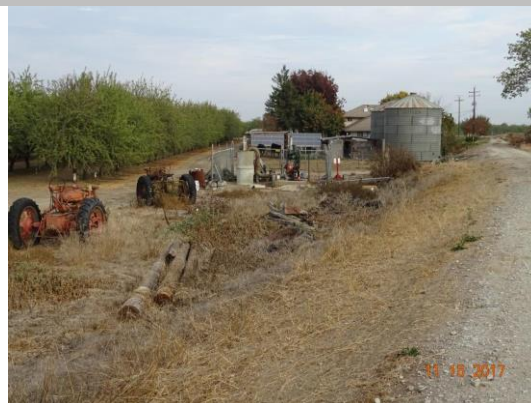
Photo 1 of 1 : SP_2018_NA0011_142_14_20180411_00005.jpg

LM Start	0.74	Rating **	U	Issue No.	14
LM End	0.78	Issue Type +	En	Location *	LS
Category	Earthen Levee			GPS Latitude/Longitude	
				Start	End
Item	Encroachments			37.052619 °	37.053238 °
				-120.417726 °	-120.417488 °
DWR ID	DWR_NA0011_01_s_2013_14				
Comment Code					
EQ : Equipment					
Inspector Comment					
Farm equipment and debris placed within the easement landside levee toe.

Move equipment and debris away from levee to allow inspection and access to landside slope, toe and 10-foot easement.

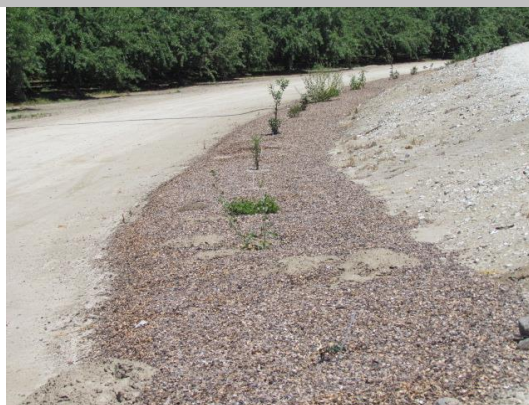
Photo 1 of 3 : SP_2018_NA0011_142_28_20180411_00011.jpg

LM Start	0.89	Rating **	U	Issue No.	28
LM End	1.15	Issue Type +	En	Location *	LS
Category	Earthen Levee			GPS Latitude/Longitude	
				Start	End
Item	Encroachments			37.054797 °	37.056328 °
				-120.416897 °	-120.412685 °
DWR ID	DWR_NA0011_01_s_2017_28				
Comment Code					
LI : Landscape Irrigation					
Inspector Comment					
This landscape has not been authorized.

Looking upstream from levee mile 0.89 to levee mile 1.15. Unauthorized landscaping on the landward toe.

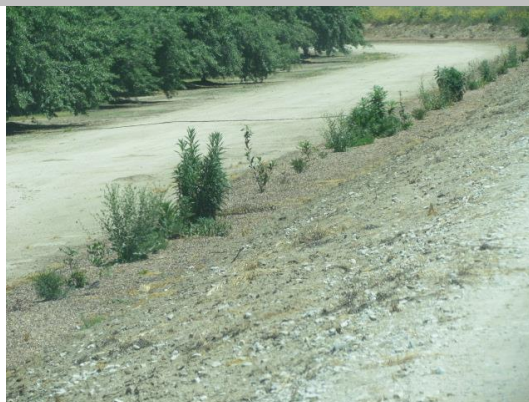
Photo 2 of 3 : SP_2018_NA0011_142_28_20180411_00012.jpg

Unauthorized landscaping continues.

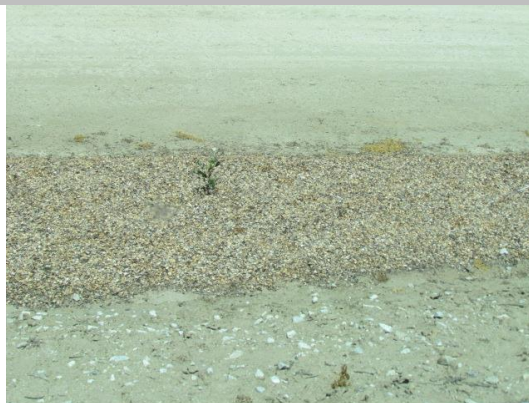
Photo 3 of 3 : SP_2018_NA0011_142_28_20180411_00013.jpg

LM Start	0.89	Rating **	U	Issue No.	28 (cont)	
LM End	1.15	Issue Type +	En	Location *	LS	
Category	Earthen Levee			GPS Latitude/Longitude		
				Start		End
Item	Encroachments			37.054797 °		37.056328 °
				-120.416897 °		-120.412685 °
DWR ID	DWR_NA0011_01_s_2017_28					
Comment Code						
LI : Landscape Irrigation						
Inspector Comment						
This landscape has not been authorized.

Unauthorized landscaping on the landward continues.

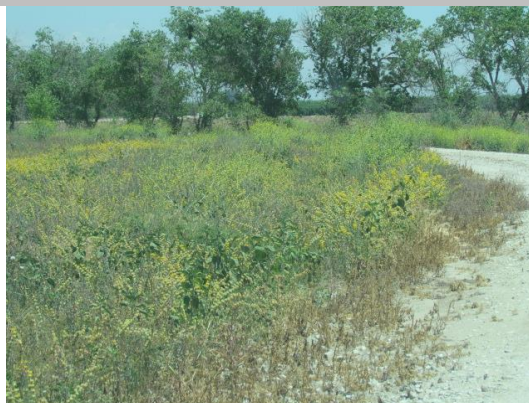
Photo 1 of 1 : SP_2018_NA0011_142_31_20180411_00014.jpg

LM Start	1.16	Rating **	U	Issue No.	31
LM End	1.25	Issue Type +	Ma	Location *	LS
Category	Earthen Levee			GPS Latitude/Longitude	
				Start	End
Item	Vegetation			37.056385 °	37.057060 °
				-120.412688 °	-120.411380 °
DWR ID	DWR_NA0011_01_s_2017_31				
Comment Code					
V2 : Remove the wild growth other than native grasses from the levee slopes.					
Inspector Comment					
Remove the unwanted weed growth from the landside slope and shoulder.

Unwanted tall weed growth on the landside shoulder and slope.

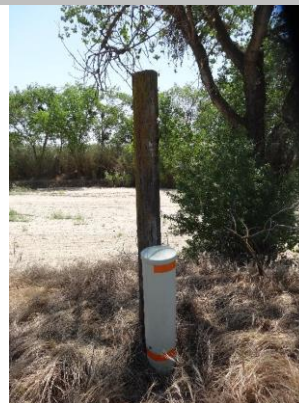
Photo 1 of 1 : UCIP_SP_2018_52612_71806.jpg

LM Start	2.09	Rating **	M	Issue No.	47
LM End	2.09	Issue Type +	En	Location *	
Category	Supplemental			GPS Latitude/Longitude	
				Start	End
Item	DWR UCIP Field Study			37.065569 °	37.065569 °
				-120.400752 °	-120.400752 °
DWR ID					
Comment Code					
Inspector Comment					
FS_ID:52612 DS_ID:21511 EP_NO: N/A Repair Type: Non-Urgent Crossing Status: Indicator Found UCIP Comments: Need to contact to owner to get contact information. FIELD_STRUCT_DESC: Telephone conduit of an unknown size or material through the levee, at an unknown depth. [Additional Reference(s): DWR Levee Log, 2005]. FS Date: 5/6/2014

Conduit box located on waterward side.

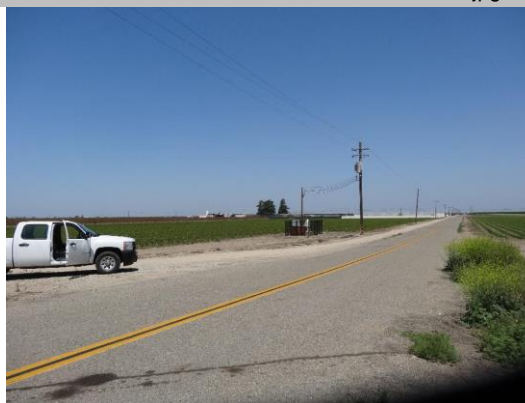
Photo 1 of 3 : UCIP_SP_2018_39845_71800.jpg

LM Start	2.10	Rating **	M	Issue No.	48
LM End	2.10	Issue Type +	En	Location *	
Category	Supplemental			GPS Latitude/Longitude	
				Start	End
Item	DWR UCIP Field Study			37.065649 °	37.065649 °
				-120.400663 °	-120.400663 °
DWR ID					
Comment Code					
Inspector Comment					
FS_ID:39845 DS_ID:25042 EP_NO: N/A Repair Type: Non-Urgent Crossing Status: Found UCIP Comments: Need to contact owner to determine if crossing goes through levee. FIELD_STRUCT_DESC: 10-inch or 12-inch drainage discharge pipe of an unknown material through the levee, at an unknown depth. Crossing visible inside a concrete standpipe on the waterside (WS). Potential pump station on the landside (LS), approximately 100 feet from the standpipe. This crossing was field discovered. FS Date: 5/6/2014

Pump station visible approximately 100 feet from concrete standpipe.

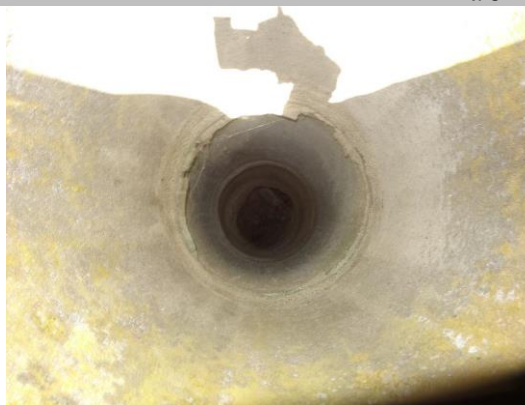
Photo 3 of 3 : UCIP_SP_2018_39845_71804.jpg

Inside view of concrete standpipe.

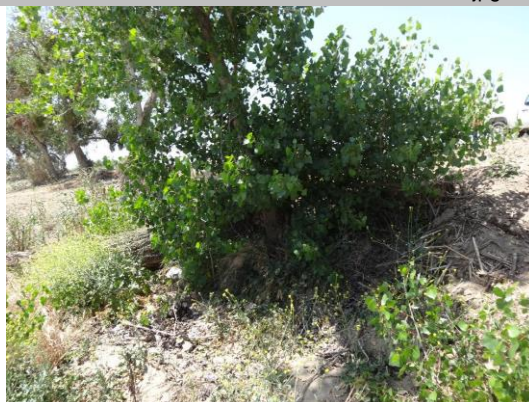
Photo 2 of 3 : UCIP_SP_2018_38226_69678.jpg

LM Start	2.37	Rating **	M	Issue No.	49
LM End	2.37	Issue Type +	En	Location *	
Category	Supplemental			GPS Latitude/Longitude	
				Start	End
Item	DWR UCIP Field Study			37.068763 °	37.068763 °
				-120.398523 °	-120.398523 °
DWR ID					
Comment Code					
Inspector Comment					
FS_ID:38226 DS_ID:21512 EP_NO: N/A Repair Type: Non-Urgent Crossing Status: Found UCIP Comments: Unable to determine details of crossing and whether crossing has been abandoned. Need to find owner and determine the alignment of crossing to confirm if pipe is being extended from opposite levee. FIELD_STRUCT_DESC: *ABANDONED* Service pole, pump, and two 36-inch standpipes on the landside (LS). Pump not found during 2014 inspection. Three standpipes found on the LS. [Additional Reference(s): DWR Levee Log, 2005]. FS Date: 5/6/2014

View of waterward slope--no signs of crossing visible.

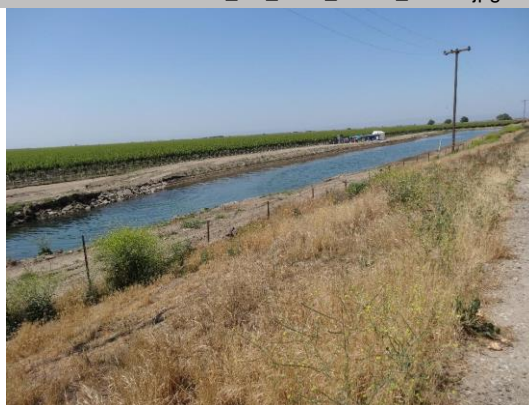
Photo 1 of 3 : UCIP_SP_2018_39686_71662.jpg

LM Start	0.01	Rating **	M	Issue No.	47
LM End	0.01	Issue Type +	En	Location *	
Category	Supplemental			GPS Latitude/Longitude	
				Start	End
Item	DWR UCIP Field Study			37.045532 °	37.045532 °
				-120.427268 °	-120.427268 °
DWR ID					
Comment Code					
Inspector Comment					
FS_ID:39686 DS_ID:21585 EP_NO: 8068 Repair Type: Non-Urgent Crossing Status: Found UCIP Comments: Unable to confirm if crossing found in the field corresponds to the crossing described under Permit 8068. Only 1 crossing found permit indicates 2 irrigation culverts. Need to contact owner to obtain additional details of crossing. FIELD_STRUCT_DESC: To retain two irrigation culverts and siphons of an unknown size or material through the levee, at an unknown depth. Located at the intersection of Ash Slough and the Chowchilla Canal. FS Date: 5/6/2014

View of landward side.

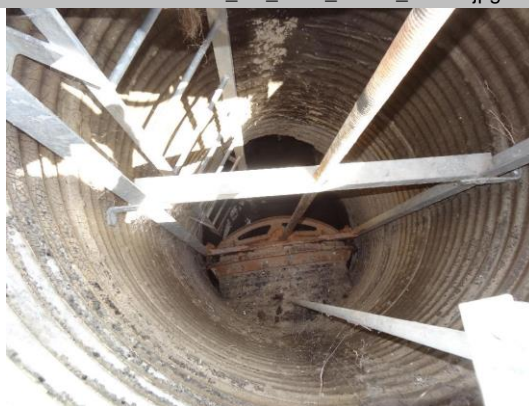
Photo 2 of 3 : UCIP_SP_2018_39686_71661.jpg

LM Start	0.01	Rating **	M	Issue No.	47 (cont)	
LM End	0.01	Issue Type +	En	Location *		
Category	Supplemental			GPS Latitude/Longitude		
				Start		End
Item	DWR UCIP Field Study			37.045532 °		37.045532 °
				-120.427268 °		-120.427268 °
DWR ID						
Comment Code						
Inspector Comment						
FS_ID:39686 DS_ID:21585 EP_NO: 8068 Repair Type: Non-Urgent Crossing Status: Found UCIP Comments: Unable to confirm if crossing found in the field corresponds to the crossing described under Permit 8068. Only 1 crossing found permit indicates 2 irrigation culverts. Need to contact owner to obtain additional details of crossing. FIELD_STRUCT_DESC: To retain two irrigation culverts and siphons of an unknown size or material through the levee, at an unknown depth. Located at the intersection of Ash Slough and the Chowchilla Canal. FS Date: 5/6/2014

View of riser located on waterward side.

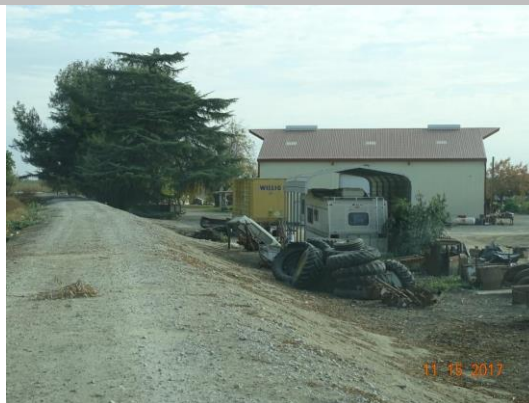
Photo 1 of 1 : SP_2018_NA0011_143_12_20180307_00008.jpg

LM Start	0.09	Rating **	U	Issue No.	12
LM End	0.14	Issue Type +	En	Location *	LS
Category	Earthen Levee			GPS Latitude/Longitude	
				Start	End
Item	Encroachments			37.045876 °	37.046118 °
				-120.425932 °	-120.424996 °
DWR ID	DWR_NA0011_02_f_2017_12				
Comment Code					
EQ : Equipment					
Inspector Comment

Move equipment away from levee slope, toe and 10-foot easement at toe to allow inspection and access.

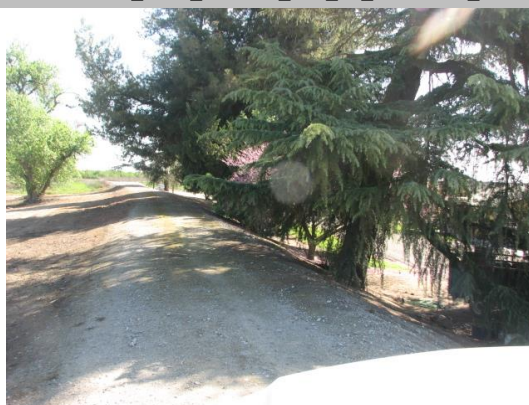
Photo 1 of 1 : SP_2018_NA0011_143_23_20180411_00038.jpg

LM Start	0.16	Rating **	U	Issue No.	23
LM End	0.23	Issue Type +	En	Location *	LS
Category	Earthen Levee			GPS Latitude/Longitude	
				Start	End
Item	Vegetation			37.046240 °	37.046583 °
				-120.424608 °	-120.423560 °
DWR ID	DWR_NA0011_02_s_2017_23				
Comment Code					
V6 : Landscaping					
Inspector Comment					
Trim the tree limbs blocking view of landward levee slope.

Looking downstream at tree on landward slope. (Spring 2018)

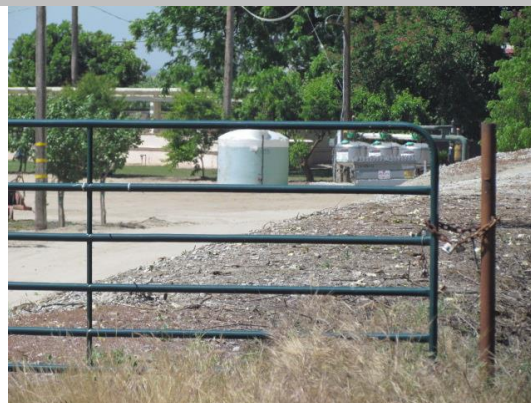
Photo 2 of 2 : SP_2018_NA0011_143_5_20180307_00006.jpg

LM Start	0.30	Rating **	M	Issue No.	5
LM End	0.30	Issue Type +	En	Location *	CR
Category	Earthen Levee			GPS Latitude/Longitude	
				Start	End
Item	Encroachments			37.047100 °	37.047100 °
				-120.422448 °	-120.422448 °
DWR ID	DWR_NA0011_02_f_2012_5				
Comment Code					
FE : Fence					
Inspector Comment					
This fence was not authorized by CVFPB. The District is aware of the fence. The landowner installed the fence and gate across the levee section because he has been broken into frequently and had many items stolen in the past. I met with the landowner 4-29-2014 and he let me put a State lock on his gate to gain access to the levee.

New photo 5-4-2017.

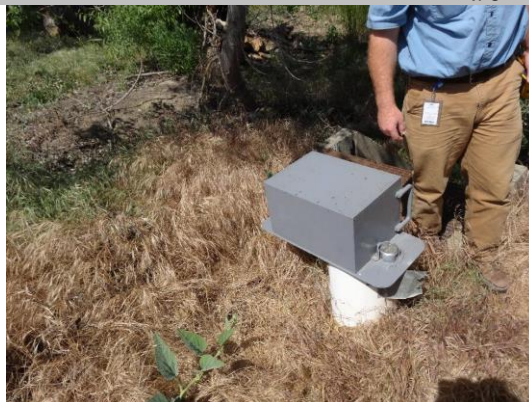
Photo 2 of 3 : UCIP_SP_2018_35764_64466.jpg

Locked box (unknown purpose) located on waterward side.

Comment Code						
Inspector Comment						
FS_ID:35764 DS_ID:21514 EP_NO: N/A Repair Type: Non-Urgent Crossing Status: Found UCIP Comments: Need to contact owner to determine details of crossing and permit information authorizing crossing. Dense vegetation limits the inspector's visibility to identify signs of pipe failure (leaks) along the slope. Recommend removing vegetation along pipe alignment to conduct proper inspection of structure and appurtenances. FIELD_STRUCT_DESC: Gravity drainage pipe of an unknown size or material through the levee, at a skew and at an unknown depth. Concrete discharge structure at the waterside (WS) end. Standpipe with gage house off the landside (LS) toe. No gage house found on the LS during inspection. [Additional Reference(s): DWR Levee Log, 2005]. FS Date: 5/6/2014

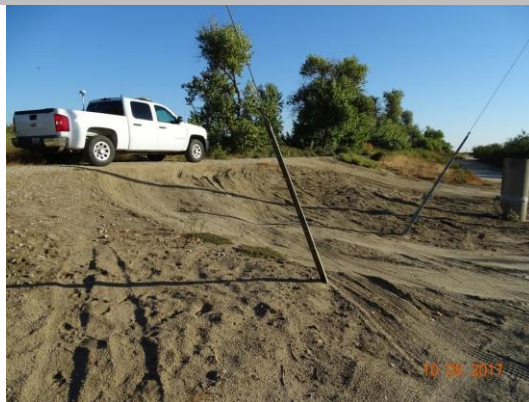
Photo 1 of 1 : SP_2018_NA0011_143_13_20180307_00009.jpg

LM Start	0.31	Rating **	M	Issue No.	13
LM End	0.31	Issue Type +	Ma	Location *	LS
Category	Earthen Levee			GPS Latitude/Longitude	
				Start	End
Item	Slope Stability			37.047266 °	37.047266 °
				-120.422393 °	-120.422393 °
DWR ID	DWR_NA0011_02_f_2017_13				
Comment Code					
S3 : Repair the levee slope damaged by vehicle traffic and prevent access where possible.					
Inspector Comment

Vehicle access to levee slope should be prevented and erosion repaired.

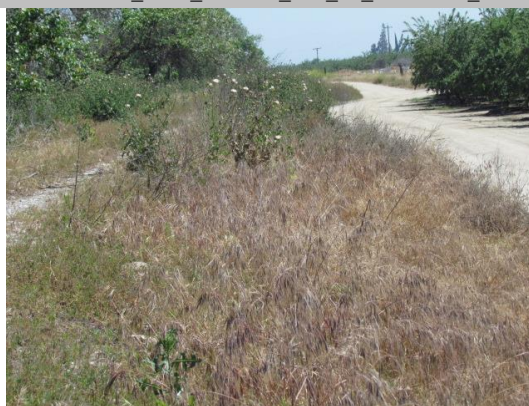
Photo 1 of 1 : SP_2018_NA0011_143_30_20180307_00014.jpg

LM Start	0.32	Rating **	U	Issue No.	30
LM End	0.97	Issue Type +	Ma	Location *	LS
Category	Earthen Levee			GPS Latitude/Longitude	
				Start	End
Item	Vegetation			37.047387 °	37.054878 °
				-120.422183 °	-120.415525 °
DWR ID	DWR_NA0011_02_s_2017_30				
Comment Code					
V2 : Remove the wild growth other than native grasses from the levee slopes.					
Inspector Comment					
Spray or mow the wild weeds on the landside levee slope.

Unwanted vegetation on the waterside levee slope.

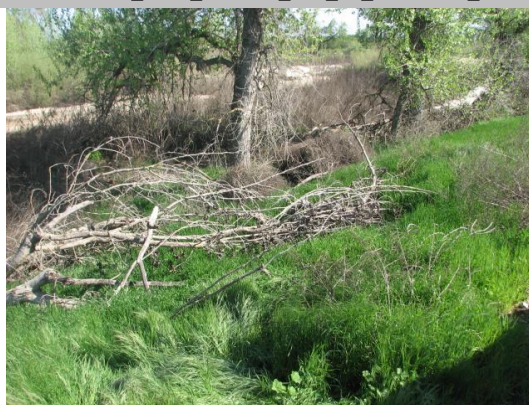
Photo 1 of 1 : SP_2018_NA0011_143_28_20180411_00039.jpg

LM Start	0.32	Rating **	M	Issue No.	28
LM End	0.32	Issue Type +	Ma	Location *	WS
Category	Earthen Levee			GPS Latitude/Longitude	
				Start	End
Item	Encroachments			37.047416 °	37.047416 °
				-120.422142 °	-120.422142 °
DWR ID	DWR_NA0011_02_f_2012_28				
Comment Code					
TR : Tree or limb					
Inspector Comment					
Remove the dead tree limbs from the waterside slope.

Looking downstream at tree limbs on waterward slope and toe. (Spring 2018)

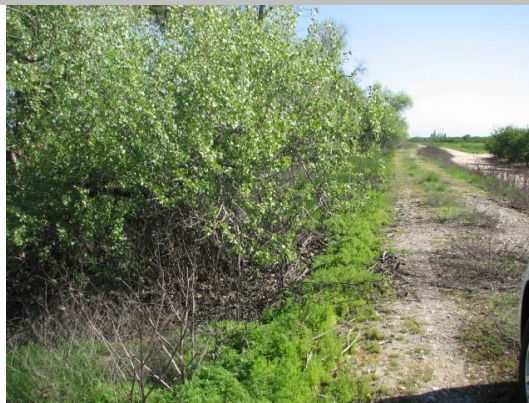
Photo 1 of 1 : SP_2018_NA0011_143_14_20180411_00040.jpg

LM Start	0.35	Rating **	M	Issue No.	14
LM End	0.41	Issue Type +	Ma	Location *	WS
Category	Earthen Levee			GPS Latitude/Longitude	
				Start	End
Item	Trim / Thin Trees			37.047653 °	37.048304 °
				-120.421813 °	-120.420967 °
DWR ID	DWR_NA0011_02_f_2017_14				
Comment Code					
T1 : Trim trees to at least five feet above ground level.					
Inspector Comment					
Waterside tree branches hanging over crown interfere with crown access and waterside visibility.

Looking downstream at untrimmed tree on waterward shoulder and slope. (Spring 2018)

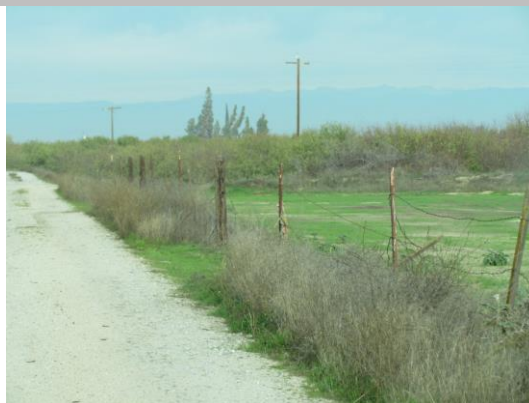
Photo 1 of 1 : SP_2018_NA0011_143_11_20180307_00007.jpg

LM Start	0.45	Rating **	M	Issue No.	11
LM End	0.53	Issue Type +	En	Location *	LS
Category	Earthen Levee			GPS Latitude/Longitude	
				Start	End
Item	Encroachments			37.048627 °	37.049342 °
				-120.420357 °	-120.419370 °
DWR ID	DWR_NA0011_02_s_2012_11				
Comment Code					
FE : Fence					
Inspector Comment					
Wire fence on the landside levee shoulder along with unwanted tall weed growth..

Fence on the landside slope.

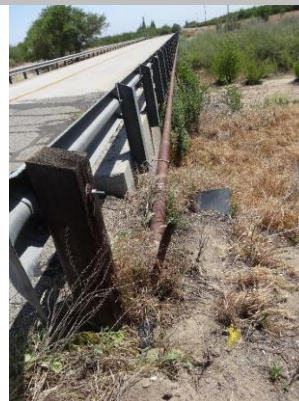
Photo 2 of 3 : UCIP_SP_2018_39923_71822.jpg

LM Start	0.94	Rating **	M	Issue No.	49	
LM End	0.94	Issue Type +	En	Location *		
Category	Supplemental			GPS Latitude/Longitude		
				Start	End	
Item	DWR UCIP Field Study			37.054547 °	37.054547 °	
				-120.415826 °	-120.415826 °	
DWR ID						
Comment Code						
Inspector Comment						
FS_ID:39923						
DS_ID:25043						
EP_NO: N/A						
Repair Type: Non-Urgent						
Crossing Status: Found						
UCIP Comments: Need to contact owner to determine status. Need permit authorizing work.						
FIELD_STRUCT_DESC: 5-inch steel communications conduit along the downstream face of the bridge. The upstream face has a 2-inch pipe cut at the corner. This crossing was field discovered.						
FS Date: 5/6/2014

View of steel conduit through levee and above channel.

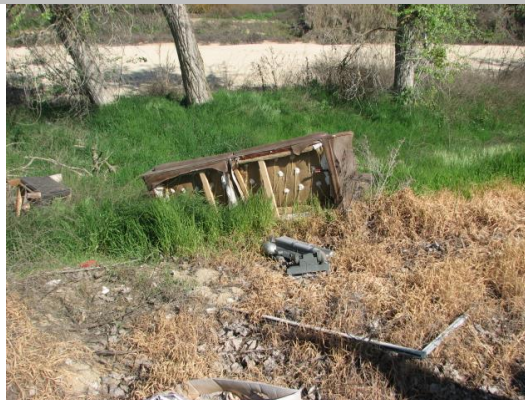
Photo 1 of 1 : SP_2018_NA0011_143_16_20180411_00042.jpg

LM Start	0.96	Rating **	M	Issue No.	16
LM End	0.96	Issue Type +	Ma	Location *	WS
Category	Earthen Levee			GPS Latitude/Longitude	
				Start	End
Item	Encroachments			37.054733 °	37.054733 °
				-120.415732 °	-120.415732 °
DWR ID	DWR_NA0011_02_f_2017_16				
Comment Code					
GA : Garbage					
Inspector Comment					
Remove furniture and other debris from waterside slope.

Looking downstream at garage on waterward slope. (Spring 2018)

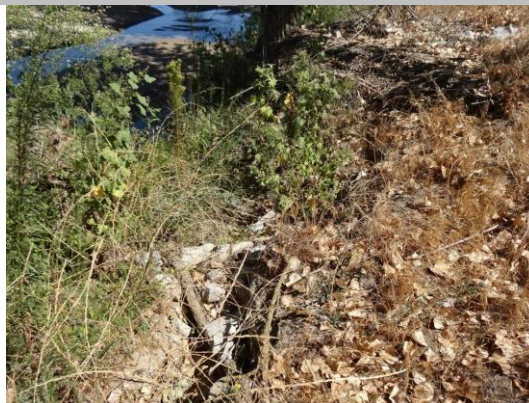
Photo 3 of 4 : SP_2018_NA0011_143_1_20180307_00003.jpg

Comment Code						
Inspector Comment						
09/20/2017: No significant change observed. 07/22/2016: No significant change observed. 09/08/2015: No significant change observed. 07/22/2014: No significant change observed. 08/30/2013: No significant change observed. 07/31/2012: Site was visited on 07/24/2012. No significant change observed. Dense vegetation around the site 08/09/2011: Site was inspected. No visible change was observed from the previous condition. A fallen tree was seen at the levee toe about 20 feet upstream, and tree root exposed. There has been no report from the district that this site was corrected. 11/30/2010: Site was not inspected due to time constraints. There have been no reports from the district that the site was corrected. Continue to monitor site during flood events. 08/05/2010: Recommended for annual assessment and monitoring during flood events, per CLRO. 2009: Site is recommended as a local maintenance issue, per Critical Levee Repair Office, Critical Erosion Sites Evaluation 2008 Report; site was previously rated "M" 9/6/2007: Undercutting of the toe; several trees along the WS slope with roots exposed. [2017 Site ID:NA0011U02RM2.57]

Vegetation debris at the site.

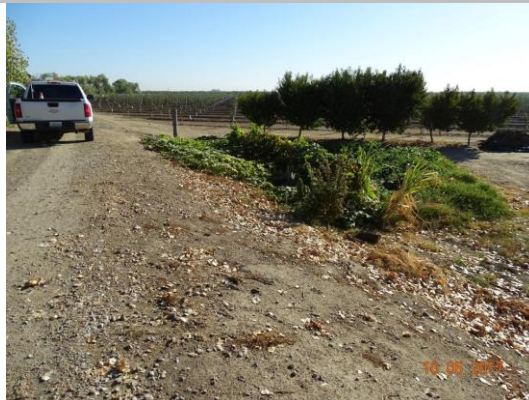
Photo 1 of 2 : SP_2018_NA0011_143_18_20180307_00010.jpg

LM Start	1.24	Rating **	M	Issue No.	18
LM End	1.24	Issue Type +	En	Location *	LS
Category	Earthen Levee			GPS Latitude/Longitude	
				Start	End
Item	Vegetation			37.056226 °	37.056226 °
				-120.411066 °	-120.411066 °
DWR ID	DWR_NA0011_02_f_2017_18				
Comment Code					
V6 : Landscaping					
Inspector Comment					
Landowner removed most of the landscaping expect for cactus at landward toe.

Modify or remove existing landscaping to allow visibility and access.

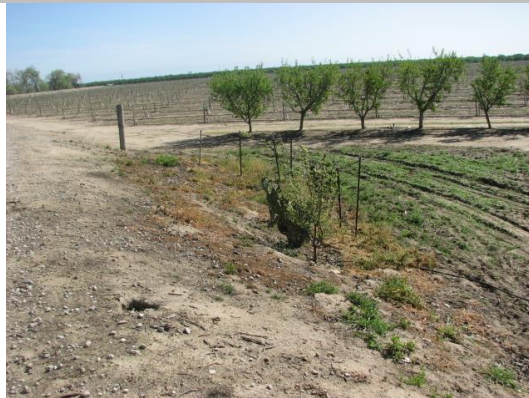
Photo 2 of 2 : SP_2018_NA0011_143_18_20180411_00043.jpg

Looking downstream at cactus on landward toe. (Spring 2018)

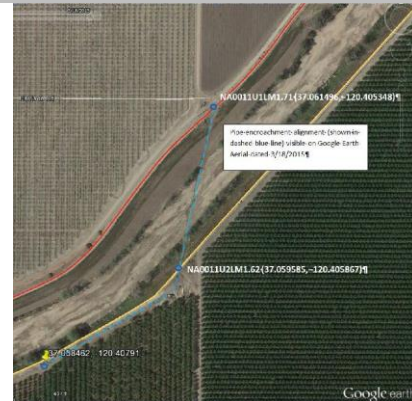
Photo 1 of 3 : UCIP_SP_2018_49978_75220.jpg

FS_ID:49978
DS_ID:25457
EP_NO: N/A
Repair Type: Non-Urgent
Crossing Status: Found
UCIP Comments: 7/14/2016 Repair in progress--According to LMA representative, Dario Dominguez, owner has repaired levee slope and compacted material per CVFPB's requirement (compaction tests have been performed). Need to confirm compaction tests were provided to DWR Inspector-Herman Phillips. (DWR UCIP - omagana)6/14/2016
Levee disturbed without prior authorization, it appears that the pipe owner did not notify CVFPB of the construction activity. Crossing was added to UCIP database. Spoke to Herman Phillips (DWR Levee Inspector) regarding unauthorized pipe installation along LS toe of U2. The LS toe of U2 (approximately 731 feet) was disturbed. DWR Inspector mentioned that Dario Dominguez with Madera County Flood Control, LMA representative, has sent the pipe owner notification of unauthorized excavation to replace existing pipe along U2 LS toe, dated May 5, 2016. After reviewing the timed aerial photographs (aerials) under Google Earth a new discovery was made regarding the extend of the area disturbed. Based on the aerials it appears that the new pipe system goes through U1 and U2 levees, across Ash Slough, and along LS toe of U2. The pipe through the levees and channel appears to tie into the work currently being done on the LS toe of U2. Both U1 and U2 levees appear to have been disturbed during 2014-2015. The aerials show that the crossing was not present in the aerial dated 4/5/2014, crossing was not present during the 2014 UCIP Inspection dated 5/6/2014, and the crossing was present in the aerial dated 3/18/2015. According to DWR Inspector, Dario Dominguez with Madera County Flood Control was notified of the additional unauthorized encroachment issue (unauthorized work completed in 2014-2015 on both levees and the channel) that could be related to the trench work being completed by Mr. Sterling. (DWR UCIP - omagana)

FIELD_STRUCT_DESC: *ILLEGAL ENCROACHMENT* 10-inch to 12-inch irrigation siphon pipe of an unknown material through both levees and across the channel, at an unknown depth. The pipe starts on the landside (LS) toe of Unit 1 (U1) and continues across the channel and through the Unit 2 (U2) levee. The pipe then runs along the LS toe of U2 for approximately 731 feet. The pipe along the LS toe of U2 starts at 37.059237, -120.406025, and ends at 37.058462, -120.40791. This crossing was field discovered.
FS Date: 7/14/2016

Assumed alignment of pipe through the levees and along LS toe of Unit 2. (Source: Google Earth, 3/18/2015)

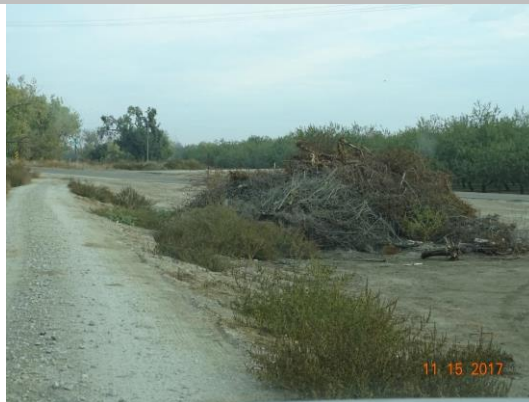
Photo 1 of 1 : SP_2018_NA0011_143_24_20180307_00011.jpg

LM Start	2.00	Rating **	U	Issue No.	24
LM End	2.00	Issue Type +	En	Location *	LS
Category	Earthen Levee			GPS Latitude/Longitude	
				Start	End
Item	Encroachments			37.063642 °	37.063642 °
				-120.401434 °	-120.401434 °
DWR ID	DWR_NA0011_02_f_2017_24				
Comment Code					
PR : Prunings					
Inspector Comment					
Large pruning/burn pile may be intermittent issue, but shold be located away from levee toe.

Remove prunings pile to allow inspection and access to landside levee slope and toe.

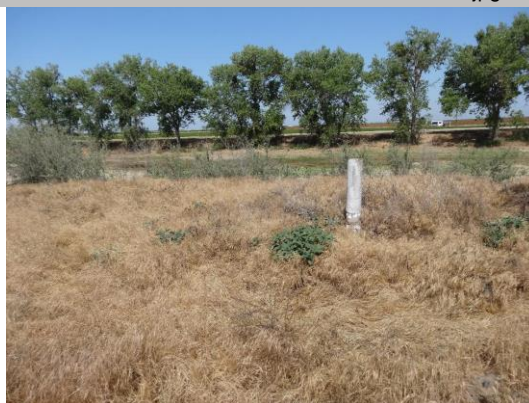
Photo 1 of 3 : UCIP_SP_2018_39924_71809.jpg

LM Start	2.03	Rating **	M	Issue No.	52
LM End	2.03	Issue Type +	En	Location *	
Category	Supplemental			GPS Latitude/Longitude	
				Start	End
Item	DWR UCIP Field Study			37.064087 °	37.064087 °
				-120.401194 °	-120.401194 °
DWR ID					
Comment Code					
Inspector Comment					
FS_ID:39924 DS_ID:25044 EP_NO: N/A Repair Type: Non-Urgent Crossing Status: Found UCIP Comments: Need to contact owner to determine status. FIELD_STRUCT_DESC: 10-inch pipes located on waterside (WS). Unsure if these pipes go through the levee. These pipes were field discovered. FS Date: 5/6/2014

Tall concrete standpipe visible on waterward side.

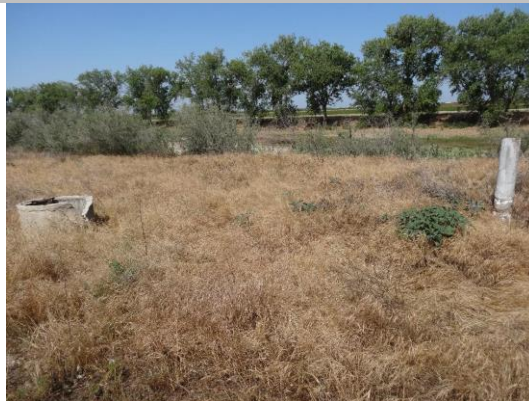
Photo 2 of 3 : UCIP_SP_2018_39924_71808.jpg

LM Start	2.03	Rating **	M	Issue No.	52 (cont)
LM End	2.03	Issue Type +	En	Location *	
Category	Supplemental			GPS Latitude/Longitude	
				Start	End
Item	DWR UCIP Field Study			37.064087 °	37.064087 °
				-120.401194 °	-120.401194 °
DWR ID					
Comment Code					
Inspector Comment					
FS_ID:39924 DS_ID:25044 EP_NO: N/A Repair Type: Non-Urgent Crossing Status: Found UCIP Comments: Need to contact owner to determine status. FIELD_STRUCT_DESC: 10-inch pipes located on waterside (WS). Unsure if these pipes go through the levee. These pipes were field discovered. FS Date: 5/6/2014

Concrete standpipes visible on waterward side--dense vegetation on waterward side.

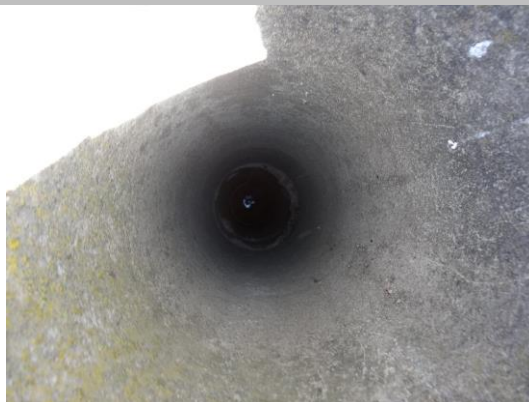
Photo 3 of 3 : UCIP_SP_2018_39924_71807.jpg

Inside view of 10-inch concrete standpipe.

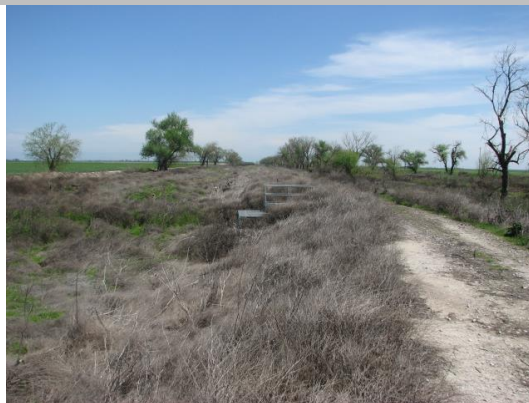
Photo 1 of 2 : SP_2018_NA0011_144_3_20180411_00018.jpg

Looking downstream at landward slope. (Spring 2018)

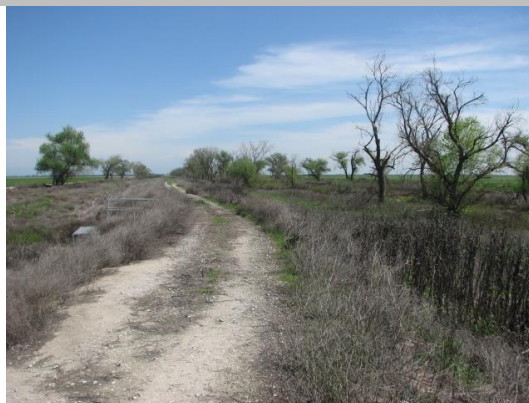
Photo 1 of 2 : SP_2018_NA0011_144_9_20180411_00019.jpg

LM Start	0.00	Rating **	U	Issue No.	9
LM End	1.51	Issue Type +	Ma	Location *	WS
Category	Earthen Levee			GPS Latitude/Longitude	
				Start	End
Item	Vegetation			36.996596 °	36.996613 °
				-120.373711 °	-120.346565 °
DWR ID	DWR_NA0011_03_s_2017_9				
Comment Code					
V2 : Remove the wild growth other than native grasses from the levee slopes.					
Inspector Comment					
Remove the wild growth from the waterside levee section, spray and mow.

Looking downstream at wild growth on waterward slope. (Spring 2018)

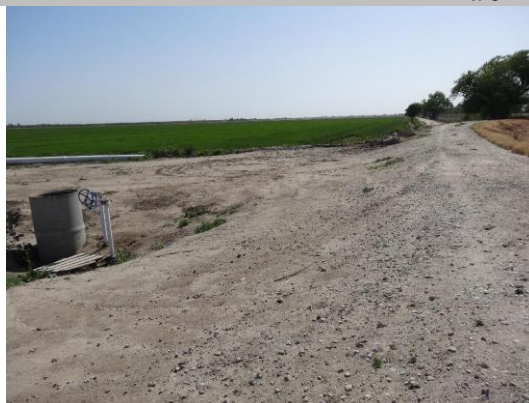
Photo 1 of 3 : UCIP_SP_2018_35767_64476.jpg

LM Start	0.00	Rating **	M	Issue No.	46
LM End	0.00	Issue Type +	En	Location *	
Category	Supplemental			GPS Latitude/Longitude	
				Start	End
Item	DWR UCIP Field Study			36.996593 °	36.996593 °
				-120.373636 °	-120.373636 °
DWR ID					
Comment Code					
Inspector Comment					
FS_ID:35767 DS_ID:21516 EP_NO: N/A Repair Type: Non-Urgent Crossing Status: Found UCIP Comments: Unable to confirm if crossing is still being used. Need to contact owner to determine status of crossing. FIELD_STRUCT_DESC: 18-inch steel irrigation discharge pipe through the levee, at an unknown depth. Slant pump on the waterside (WS) slope. The levee log indicates that the abandonment of the Chowchilla Canal Siphon was backfilled through the levee section. [Additional Reference(s): DWR Levee Log, 2005]. FS Date: 5/6/2014

View of landward side.

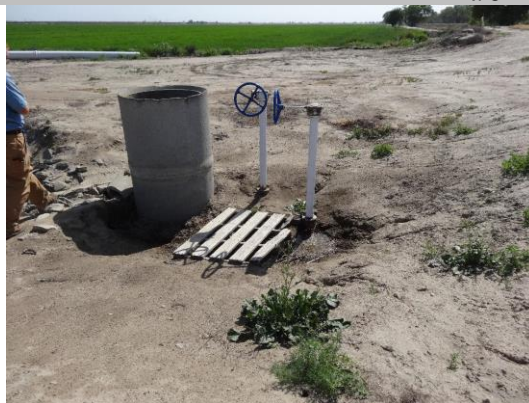
Photo 2 of 3 : UCIP_SP_2018_35767_64475.jpg

LM Start	0.00	Rating **	M	Issue No.	46 (cont)	
LM End	0.00	Issue Type +	En	Location *		
Category	Supplemental			GPS Latitude/Longitude		
				Start	End	
Item	DWR UCIP Field Study			36.996593 °	36.996593 °	
				-120.373636 °	-120.373636 °	
DWR ID						
Comment Code						
Inspector Comment						
FS_ID:35767 DS_ID:21516 EP_NO: N/A Repair Type: Non-Urgent Crossing Status: Found UCIP Comments: Unable to confirm if crossing is still being used. Need to contact owner to determine status of crossing. FIELD_STRUCT_DESC: 18-inch steel irrigation discharge pipe through the levee, at an unknown depth. Slant pump on the waterside (WS) slope. The levee log indicates that the abandonment of the Chowchilla Canal Siphon was backfilled through the levee section. [Additional Reference(s): DWR Levee Log, 2005]. FS Date: 5/6/2014

Close up of concrete standpipe and multiple positive closure devices.

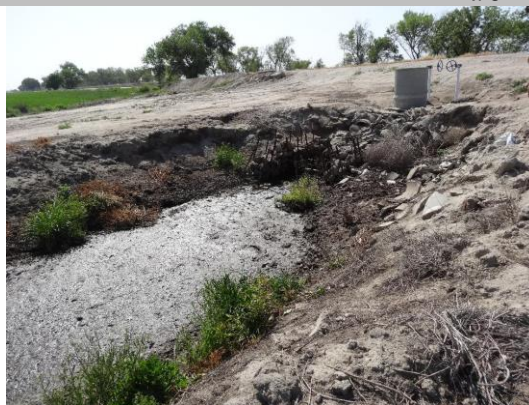
Photo 3 of 3 : UCIP_SP_2018_35767_64474.jpg

Canal located on landward side.

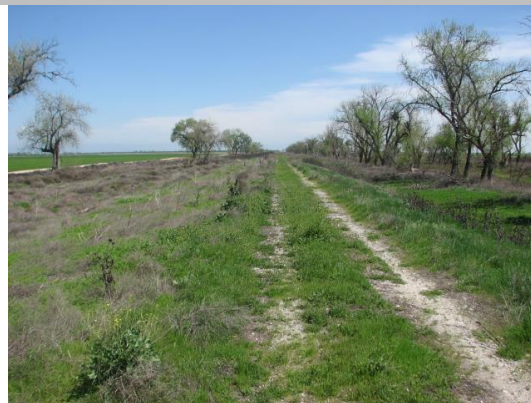
Photo 1 of 1 : SP_2018_NA0011_144_32_20180411_00020.jpg

LM Start	0.08	Rating **	M	Issue No.	32
LM End	1.51	Issue Type +	Ma	Location *	CR
Category	Earthen Levee			GPS Latitude/Longitude	
				Start	End
Item	Crown Surface / Depressions / Rutting			36.996264 °	36.996613 °
				-120.372350 °	-120.346570 °
DWR ID	DWR_NA0011_03_s_2014_32				
Comment Code					
C3 : Add appropriate gravel or road base. Grade and compact.					
Inspector Comment					
Regrade the crown for proper drainage and add more rock to crown.

Looking downstream at levee crown. (Spring 2018)

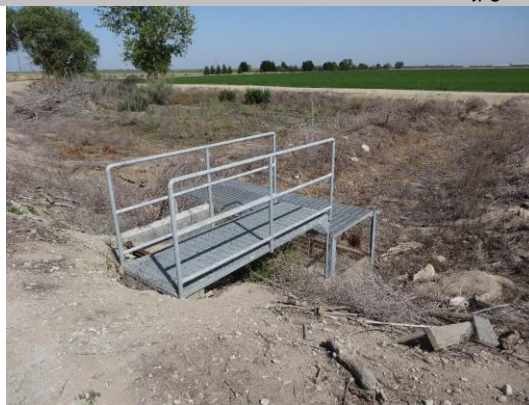
Photo 3 of 3 : UCIP_SP_2018_38228_69688.jpg

LM Start	0.10	Rating **	M	Issue No.	47 (cont)	
LM End	0.10	Issue Type +	En	Location *		
Category	Supplemental			GPS Latitude/Longitude		
				Start	End	
Item	DWR UCIP Field Study			36.996177 °	36.996177 °	
				-120.371967 °	-120.371967 °	
DWR ID						
Comment Code						
Inspector Comment						
FS_ID:38228						
DS_ID:21517						
EP_NO: N/A						
Repair Type: Non-Urgent						
Crossing Status: Found						
UCIP Comments: Need to contact owner to determine status of crossing. Unable to determine if crossing is in use.						
FIELD_STRUCT_DESC: 36-inch corrugated metal gravity drainage pipe through the levee, 7.3 feet below the crown. Headwall and wing wall on each end. Flap gate on the waterside (WS) end. [Additional Reference(s): DWR Levee Log, 2005].						
FS Date: 5/6/2014

View of landward side.

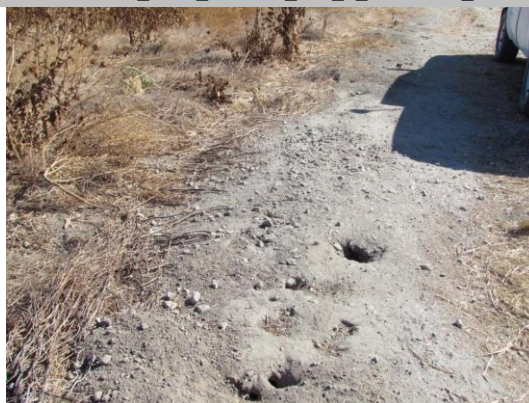
Photo 6 of 6 : SP_2018_NA0011_144_6_20180307_00003.jpg

LM Start	0.40	Rating **	U	Issue No.	6 (cont)	
LM End	1.51	Issue Type +	Ma	Location *	LS	
Category	Earthen Levee			GPS Latitude/Longitude		
				Start		End
Item	Animal Control			36.996208 °		36.996607 °
				-120.366550 °		-120.346568 °
DWR ID	DWR_NA0011_03_f_2016_6					
Comment Code						
A1 : Exterminate rodents and backfill and compact or grout burrows.						
Inspector Comment						
LMA should install rodent bait stations placed along the landside slope and or shoulder at levee miles listed. No new photo was taken. Unable to see the ground, observed rodents running across the roadway.

Berenda Slough Unit 3 levee miles 0.40-1.51 landside shoulder and slope.

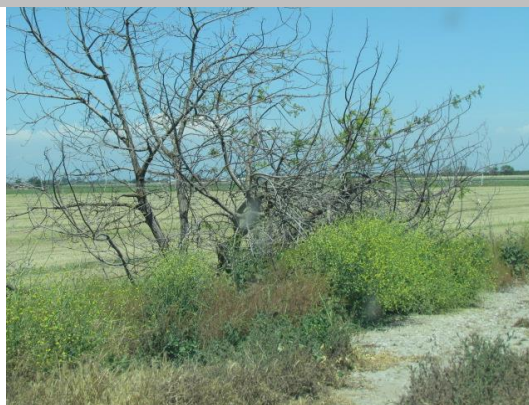
Photo 2 of 2 : SP_2018_NA0011_144_11_20180307_00009.jpg

levee mile 1.04-1.05 landside slope and shoulder wild walnut tree growth was covered with leaves that blocked the view of the levee section.

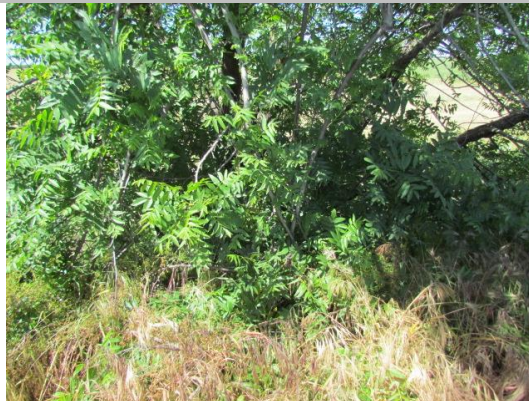
Photo 2 of 2 : SP_2018_NA0011_144_17_20180307_00011.jpg

LM Start	1.24	Rating **	U	Issue No.	17 (cont)	
LM End	1.29	Issue Type +	Ma	Location *	LS	
Category	Earthen Levee			GPS Latitude/Longitude		
				Start		End
Item	Trim / Thin Trees			36.996632 °		36.996600 °
				-120.351463 °		-120.350539 °
DWR ID	DWR_NA0011_03_s_2012_17					
Comment Code						
T2 : Thin trees to allow visibility of the ground and room to flood fight.						
Inspector Comment						
The cluster of walnut trees should be removed from the levee section landward.

Looking upstream from landside slope tree has blocked view of the slope and shoulder.

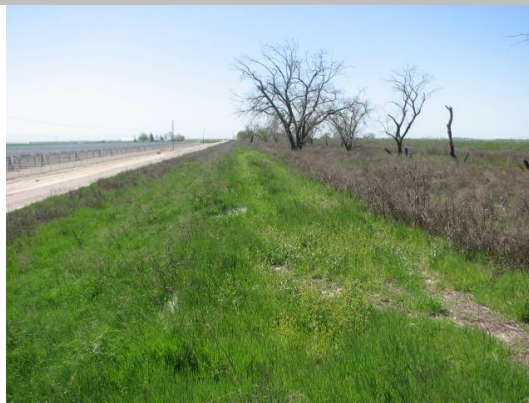
Photo 1 of 2 : SP_2018_NA0011_145_8_20180411_00019.jpg

Looking upstream from 0.00 at wild growth on levee crown. (Spring 2018)

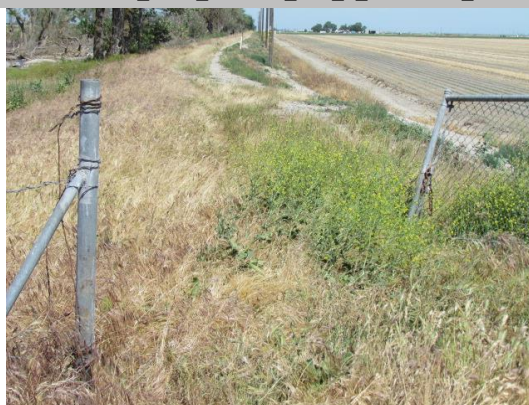
Photo 2 of 2 : SP_2018_NA0011_145_8_20180307_00003.jpg

Looking upstream from levee mile 0.01 at the wild vegetation growing on the grown roadway.

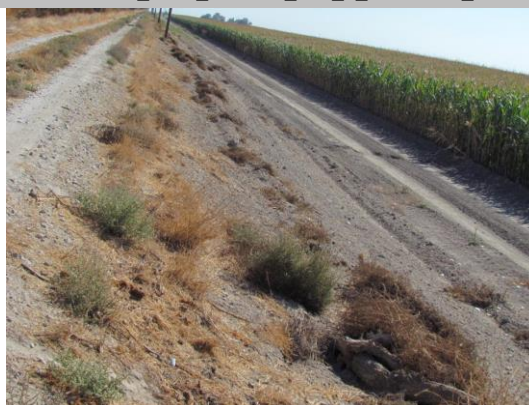
Photo 1 of 1 : SP_2018_NA0011_145_3_20180307_00001.jpg

LM Start	0.02	Rating **	U	Issue No.	3
LM End	0.97	Issue Type +	Ma	Location *	LS
Category	Earthen Levee			GPS Latitude/Longitude	
				Start	End
Item	Slope Stability			36.995506 °	36.995550 °
				-120.373233 °	-120.355935 °
DWR ID	DWR_NA0011_04_f_2016_3				
Comment Code					
S1 : Repair slope instability.					
Inspector Comment					
The slope in this area has been damaged by farm equipment on the slope.

Berenda Slough Unit 4 Looking upstream from levee mile 0.14-0.97.

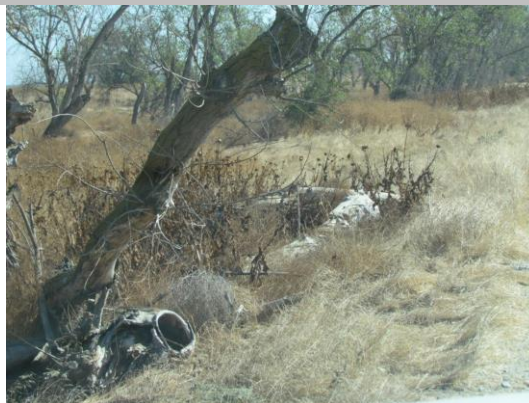
Photo 1 of 1 : SP_2018_NA0011_145_16_20180307_00013.jpg

LM Start	0.47	Rating **	U	Issue No.	16
LM End	0.47	Issue Type +	Ma	Location *	WS
Category	Earthen Levee			GPS Latitude/Longitude	
				Start	End
Item	Encroachments			36.995603 °	36.995603 °
				-120.364978 °	-120.364978 °
DWR ID	DWR_NA0011_04_s_2014_16				
Comment Code					
TR : Tree or limb					
Inspector Comment					
This dead tree on water ward slope should be removed from levee section. No change. 2017

Berenda Slough Unit 4 levee mile 0.47 looking back upstream.

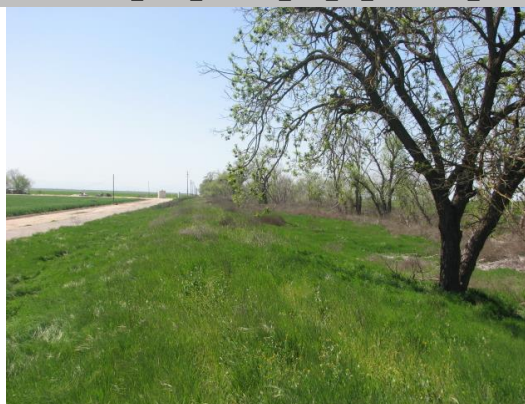
Photo 1 of 1 : SP_2018_NA0011_145_10_20180411_00026.jpg

LM Start	1.19	Rating **	U	Issue No.	10
LM End	1.19	Issue Type +	Ma	Location *	WS
Category	Earthen Levee			GPS Latitude/Longitude	
				Start	End
Item	Trim / Thin Trees			36.995566 °	36.995566 °
				-120.352038 °	-120.352038 °
DWR ID	DWR_NA0011_04_f_2017_10				
Comment Code					
T4 : Trim trees over roadway to at least 12 feet above ground level.					
Inspector Comment					
Trim branches hanging over crown inhibiting access.

Looking upstream at tree on waterward slope. (Spring 2018)

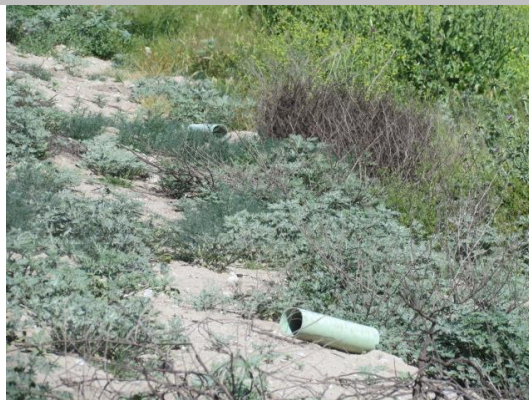
Photo 1 of 5 : SP_2018_NA0011_145_11_20180307_00004.jpg

LM Start	1.50	Rating **	U	Issue No.	11 (cont)
LM End	2.28	Issue Type +	Ma	Location *	LS

Berenda Slough looking upstream levee mile 0.62 landward.

LM Start	1.50	Rating **	U	Issue No.	11 (cont)	
LM End	2.28	Issue Type +	Ma	Location *	LS	
Category	Earthen Levee			GPS Latitude/Longitude		
				Start		End
Item	Animal Control			36.995590 °		37.003740 °
				-120.346406 °		-120.336877 °
DWR ID	DWR_NA0011_04_f_2016_11					
Comment Code						
A1 : Exterminate rodents and backfill and compact or grout burrows.						
Inspector Comment						
Exterminate the rodents and backfill and compact or grout the burrows in this area listed.

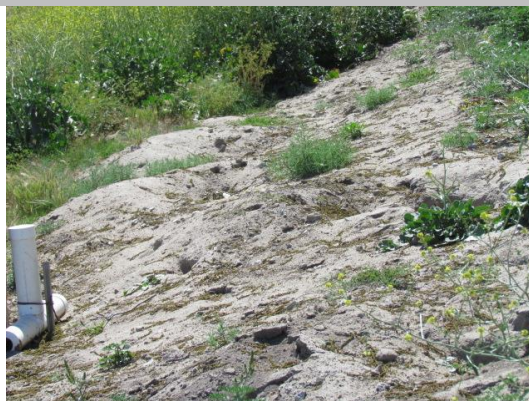
Photo 3 of 5 : SP_2018_NA0011_145_11_20180307_00006.jpg

Berenda Slough looking downstream levee 0.62 landside slope covered with rodent holes to levee mile 2.09.

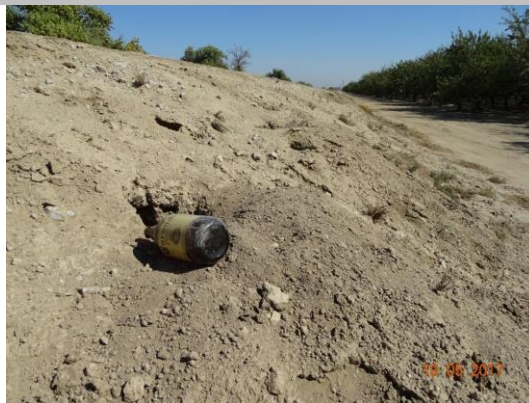
Photo 4 of 5 : SP_2018_NA0011_145_11_20180307_00007.jpg

Rodent activity at LM 2.27.

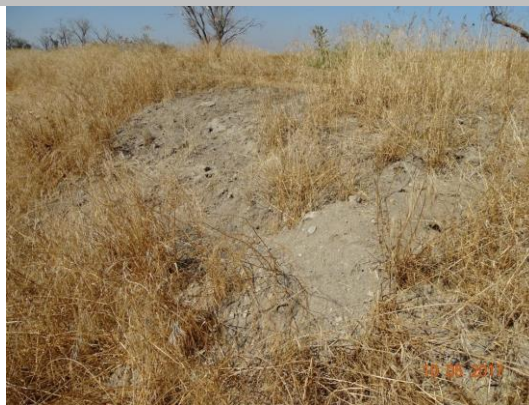
Photo 5 of 5 : SP_2018_NA0011_145_11_20180307_00008.jpg

Rodent activity at LM 1.44.

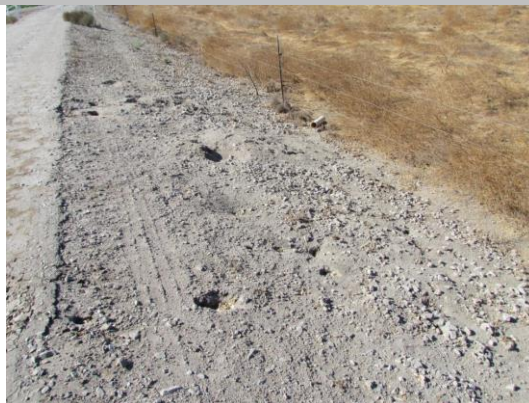
Photo 1 of 1 : SP_2018_NA0011_145_30_20180307_00014.jpg

Berenda Slough levee mile 1.63-2.23 looking upstream at waterside slope.

LM Start	1.50	Rating **	U	Issue No.	30
LM End	2.28	Issue Type +	Ma	Location *	WS
Category	Earthen Levee			GPS Latitude/Longitude	
				Start	End
Item	Animal Control			36.995590 °	37.003740 °
				-120.346406 °	-120.336877 °
DWR ID	DWR_NA0011_04_f_2014_30				
Comment Code					
A1 : Exterminate rodents and backfill and compact or grout burrows.					
Inspector Comment					
Bait stations are needed in Rodent infested area waterside slope and toe. No new photo.

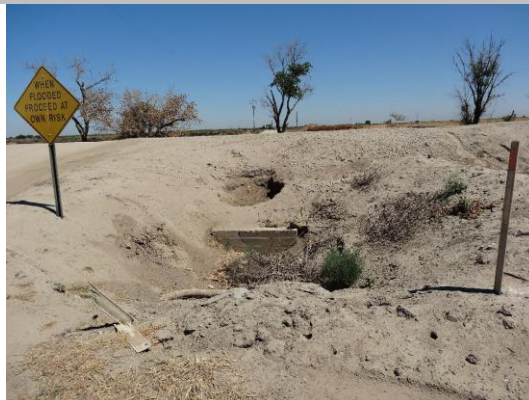
Photo 2 of 3 : UCIP_SP_2018_49977_75761.jpg

Sink hole and concrete headwall damage is visible on LS.

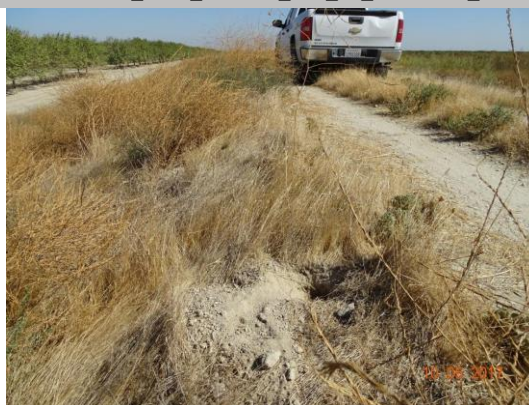
Photo 1 of 1 : SP_2018_NA0011_146_14_20180307_00003.jpg

Rodent activity on landside slope.

LM Start	0.00	Rating **	M	Issue No.	14
LM End	4.05	Issue Type +	Ma	Location *	LS
Category	Earthen Levee			GPS Latitude/Longitude	
				Start	End
Item	Animal Control			36.978520 °	36.968168 °
				-120.368567 °	-120.301035 °
DWR ID	DWR_NA0011_05_f_2016_14				
Comment Code					
A1 : Exterminate rodents and backfill and compact or grout burrows.					
Inspector Comment					
Exterminate the rodents along the landside slope and toe throughout the area to levee mile 4.05. Bait stations are needed in infested areas.

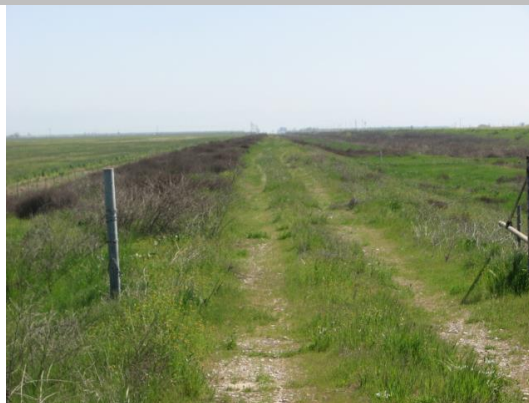
Photo 1 of 1 : SP_2018_NA0011_146_13_20180411_00020.jpg

Looking downstream at levee crown from 0.00. (Spring 2018)

LM Start	0.00	Rating **	M	Issue No.	13
LM End	4.05	Issue Type +	Ma	Location *	CR
Category	Earthen Levee			GPS Latitude/Longitude	
				Start	End
Item	Crown Surface / Depressions / Rutting			36.978548 °	36.968165 °
				-120.368454 °	-120.301151 °
DWR ID	DWR_NA0011_05_s_2012_13				
Comment Code					
C1 : Add appropriate material and re-grade the levee to bring the crown above the design elevation.					
Inspector Comment					
Regrade the crown for proper drainage. And add appropriate gravel or road base.

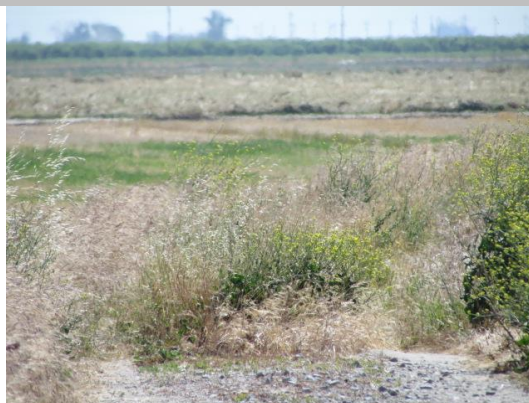
Photo 1 of 1 : SP_2018_NA0011_146_8_20180307_00002.jpg

LM Start	0.00	Rating **	U	Issue No.	8
LM End	4.05	Issue Type +	Ma	Location *	CR
Category	Earthen Levee			GPS Latitude/Longitude	
				Start	End
Item	Vegetation			36.978557 °	36.968152 °
				-120.368423 °	-120.301103 °
DWR ID	DWR_NA0011_05_f_2015_8				
Comment Code					
V9 : Keep the crown roadway free of vegetation.					
Inspector Comment					
The crown roadway must be free of all vegetation. Tall weeds blocking view of crown roadway.

Fresno River looking upstream levee mile 0.00.

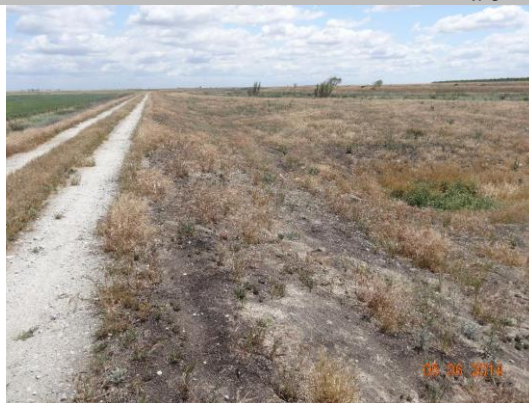
Photo 1 of 3 : UCIP_SP_2018_35795_64567.jpg

LM Start	0.18	Rating **	M	Issue No.	36
LM End	0.18	Issue Type +	En	Location *	
Category	Supplemental			GPS Latitude/Longitude	
				Start	End
Item	DWR UCIP Field Study			36.978036 °	36.978036 °
				-120.365246 °	-120.365246 °
DWR ID					
Comment Code					
Inspector Comment					
FS_ID:35795 DS_ID:21520 EP_NO: N/A Repair Type: Non-Urgent Crossing Status: Found UCIP Comments: Need to contact owner. Dense vegetation limits the inspector's visibility to identify signs of pipe failure (leaks) along the landward slope. Recommend removing vegetation along pipe alignment to conduct proper inspection of structure. FIELD_STRUCT_DESC: 36-inch corrugated metal gravity drainage pipe through the levee, 10.8 feet below the crown. Headwall and wing wall on each end. Flap gate on the waterside (WS) end. [Additional Reference(s): DWR Levee Log, 2005]. FS Date: 5/6/2014

View of waterward side.

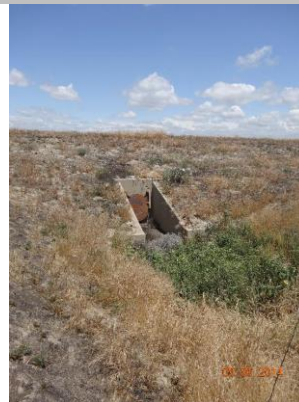
Photo 2 of 3 : UCIP_SP_2018_35795_64566.jpg

View of flap gate and concrete headwall located on waterward side.

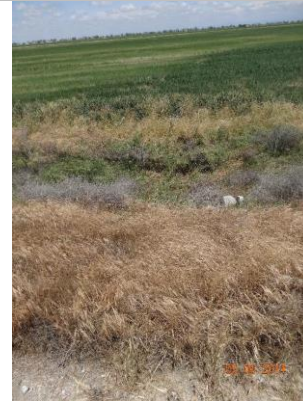
Photo 3 of 3 : UCIP_SP_2018_35795_64565.jpg

View of landward side.

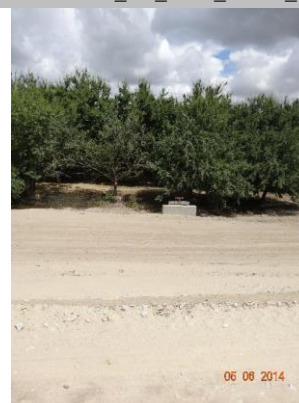
Photo 3 of 3 : UCIP_SP_2018_39006_69713.jpg

Comment Code						
Inspector Comment						
FS_ID:39006						
DS_ID:21527						
EP_NO: N/A						
Repair Type: Non-Urgent						
Crossing Status: Found						
UCIP Comments: Need to contact owner. Dense vegetation limits the inspector's visibility to identify signs of pipe failure (leaks) along the waterward slope. Recommend removing vegetation along pipe alignment to conduct proper inspection of structure and appurtenances. Slide gate buried on landward side. Recommend clearing sediment deposit on landward side.						
FIELD_STRUCT_DESC: 30-inch corrugated metal gravity drainage pipe through the levee, 9.4 feet below the crown. Headwall and wing wall on each end. Flap gate on the waterside (WS) end. [Additional Reference(s): DWR Levee Log, 2005].						
FS Date: 5/6/2014

View of landward side.
